Site Inspection, Deloy Shumway, Travertine #8 & 9, S/019/053, Grand County, Utah

ATTACHMENT Inspection Date December 12, 2002; Report Date December 26, 2002 Photographs S/019/053, Travertine #8 & 9, Deloy Shumway

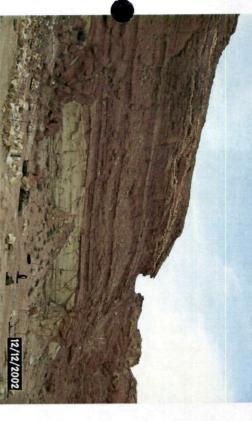
There have been a lot of changes since I last visited this site. In the lower area, the pallets and rock had been consolidated to within a fenced area at the base of a talus slope (Photo 1). Photo 2 shows the talus slope. There used to be a motor home, but I understand from Ms. Swanke that it burned and has been cleaned up. Outside of the fenced area, there was little sign of disturbance.

Photo 1. Fenced lower area.

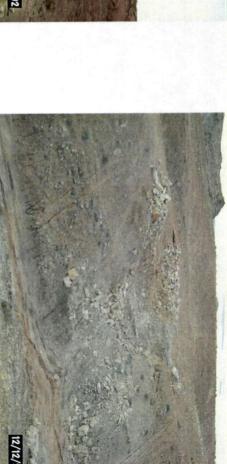
Disturbances from the mine in the upper area have not changed substantially since I was last at the site. There were a few excavations and roads scattered around this area (Photo 3).

Photo 3. Overall view of excavations in the upper area.

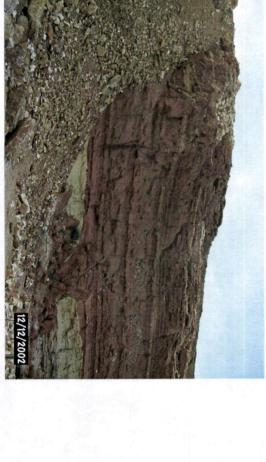
Photo 2. Talus slope on the left.

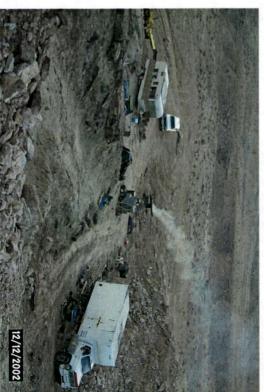
There was a camp in the upper area with a house trailer (Photo 4). Some of the other equipment in this area included a delivery truck, a Dodge Ram SUV, a tractor with backhoe and front end

Photo 4. Camp.

While I am pleased with how the operator has been limiting the size of the operation, I am concerned about the condition of the camp area. Quite simply, it needs to be cleaned up. Rule R647-3-112 requires that mine operations be maintained in a clean condition, and the site does not meet this standard.

I recognize that much of the equipment and tools are needed for the operation, but they need to be stored neatly and properly. The operator needs to be especially careful with oil products and properly dispose of used containers when they are empty. Lids should always be left on these containers whether or not they are empty. If the batteries are still usable, they should be kept somewhere other than on the ground. If they are not usable, they need to be recycled.

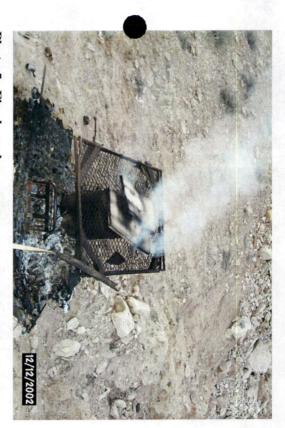
loader attachments, a compressor, and a generator. There was also a smoldering fire barrel (Photo 5), and the smoke smelled like burning plastic. There was no one present to tend the fire although I don't think there was much danger of it starting a range fire.

Photo 5. Fire barrel.

I am unsure of Bureau of Land Management regulations with regard to burning trash, but I am certain that leaving an unattended fire is not allowed. Even if burning is allowed, things like plastics, batteries, aerosol cans, and similar items should not be placed in the fire.

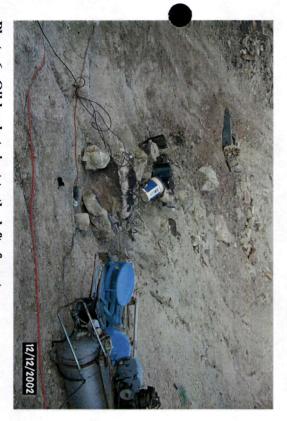
Other items in the camp area included three car batteries, four 5-gallon buckets which were either not labeled or were labeled as containing hydraulic oil (Photo 6), an unlabeled 55-gallon barrel (in addition to the fire barrel), and some gas cans only one of which had anything in it. Around the fire barrel (Photo 7) were several steel cans, aerosol cans, bed springs, and what I think was a battery charger. There was a dark spot under the left rear of the delivery truck that looked like an oil stain (Photos 8 and 10). There were also a lot of miscellaneous items scattered over the site (Photos 9-12).

Photo 6. Oil buckets just to the left of center.

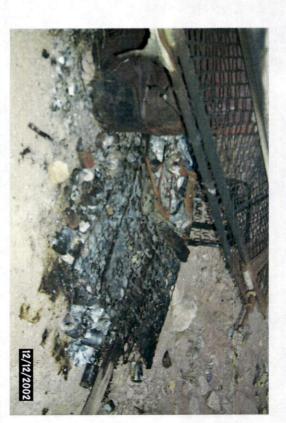
Photo 7. Debris around the fire barrel.

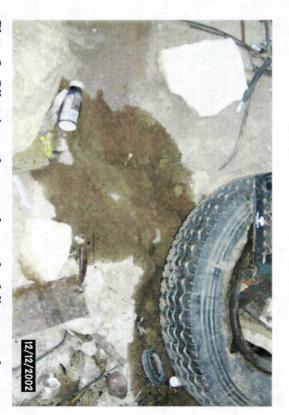
Photo 8. Oil stain on the ground near the delivery truck.
